4781 Race St

This spreadsheet performs screening level calculations to estimate the effect of peeling leaded paint on the average concentration of lead in yard soil  
**4781 Race Street**

## LBP Assessment Results

SITE NAME: VASQUEZ BOULEVARD AND I-70

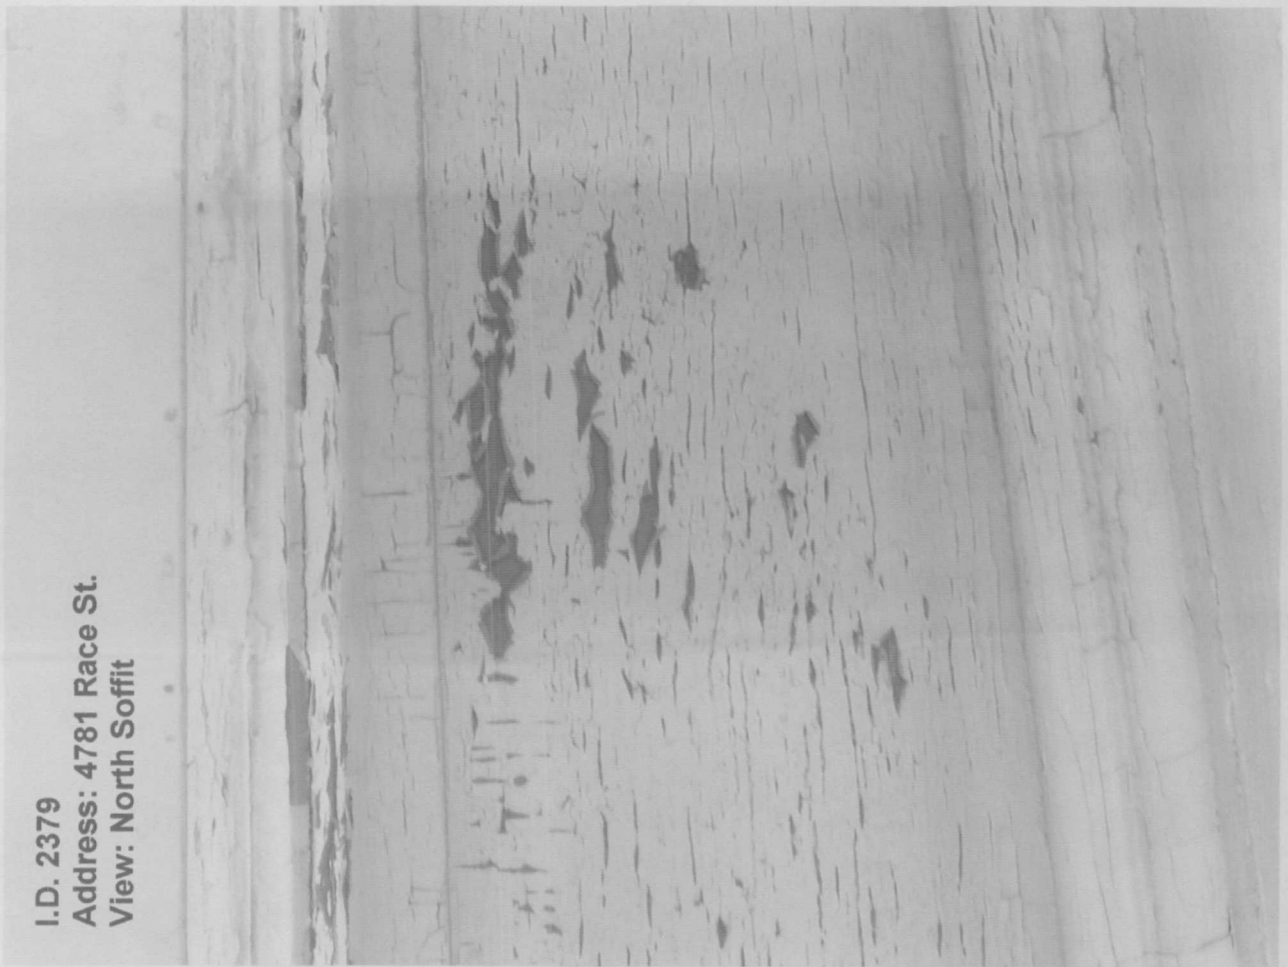
I.D. 2379  
Address: 4781 Race St.  
View: North Soffit

Window Trim/Fascia/Soffit				Patios/Decks/Porches			
	Material	Area	Peel/Chip	XRF (Lead)	Material	Area	Peel/Chip	XRF (Lead)
North	Wood Soffit	92	Peel	23.4	Soffit	42	Peel/trim	15.2
South	Wood Soffit	92	Peeling	23.4				
East	Wood	18	Peeling	23.4	porch wood	48	Cracked/peel	23.3
West	Wood	18	Peeling	23.4				
	Total				Total

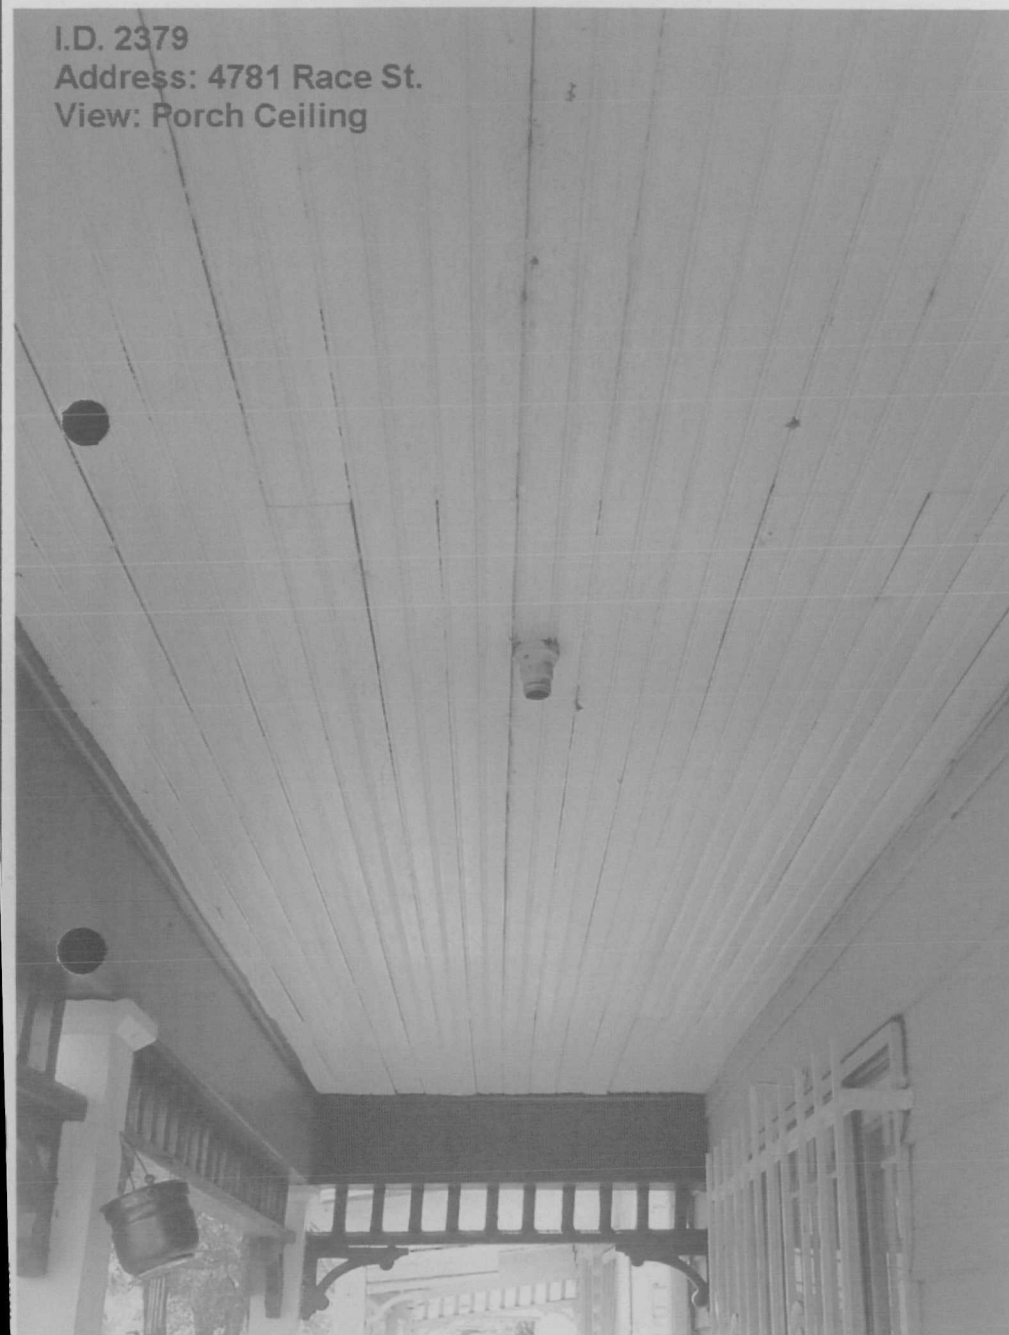
I.D. 2379  
Address: 4781 Race St.  
View: Porch Ceiling

Metal Trim/Gutters/Downspouts				(Porches) Misc Structures/Garage/Fences			
	Material	Area	Peel/Chip	XRF (Lead)	Material	Area	Peel/Chip	XRF (Lead)
North					East Ceiling	42	Cracked	12.7
South					Wood Porch	72	Cracked/peel	13.8
East								
West								
	Total				Total

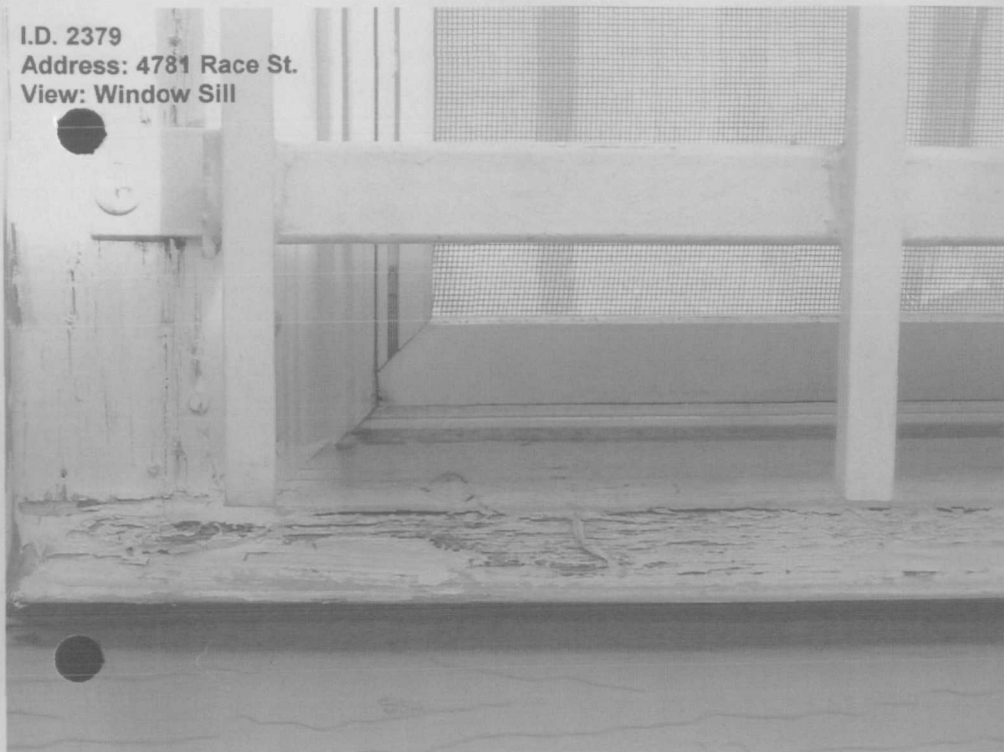
I.D. 2379  
Address: 4781 Race St.  
View: Window Sill

Exterior Walls				Doors/Trim (Window trim)			
	Material	Area	Peel/Chip	XRF (Lead)	Material	Area	Peel/Chip	XRF (Lead)
North	Alum/siding				Door trim	8	Peel	21.9
South	Alum/siding				Wood	6	Peel	
East	Alum/siding							
West	Alum/siding				Wood	6	Peel	16.7
	Total				Total

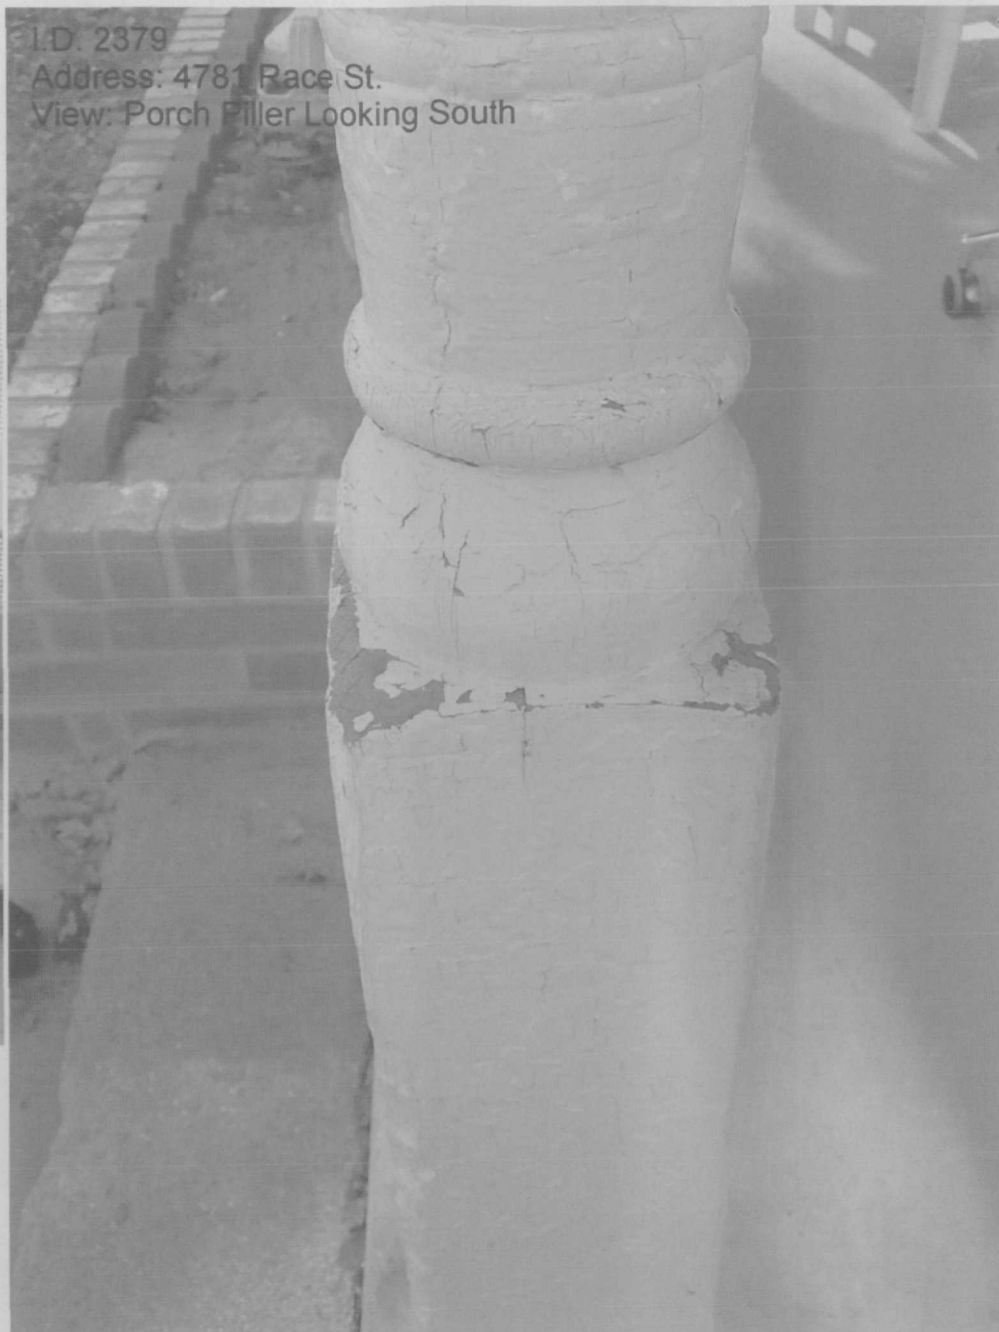
I.D. 2379  
Address: 4781 Race St.  
View: Porch Pillar Looking South

Time	Site	Component	Substrate	Side	Condition	Color	Floor	Room	Results	Depth Ind	PbC	PbC Error
11/10/2005 10:25	2379	COLUMN	WOOD	EAST	CRACKED	GREEN	FIRST	PORCH	Positive	4.62	23.3	1.5
11/10/2005 10:28	2379	HEADER	WOOD	EAST	CRACKED	BLACK	FIRST	PORCH	Positive	3.17	13.8	0.9
11/10/2005 10:38	2379	SOFFIT	WOOD	NORTH	PEELING	TAN	FIRST	PORCH	Positive	4.27	15.2	1.8
11/10/2005 10:40	2379	CEILING	WOOD	EAST	CRACKED	WHITE	FIRST	PORCH	Positive	4.58	12.7	5.1
11/10/2005 10:42	2379	SOFFIT	WOOD	SOUTH	PEELING	TAN	SECOND	OUTSIDE	Positive	6.1	23.4	2.3
11/10/2005 10:46	2379	WINDOW FRAME	WOOD	WEST	PEELING	WHITE	FIRST	OUTSIDE	Positive	4.68	16.7	1.9
11/10/2005 10:48	2379	WINDOW FRAME	WOOD	SOUTH	PEELING	WHITE	FIRST	OUTSIDE	Negative	1	0	0.02
11/10/2005 10:51	2379	EXT.WALL	WOOD	NORTH	PEELING	WHITE	FIRST	NEIGHBOR	Positive	10	22.2	2.2
11/10/2005 10:52	2379	DOORFRAME	WOOD	NORTH	PEELING	WHITE	FIRST	OUTSIDE	Positive	4.02	21.9	2.2
<b>Note: Readings are in mg/cm²</b>

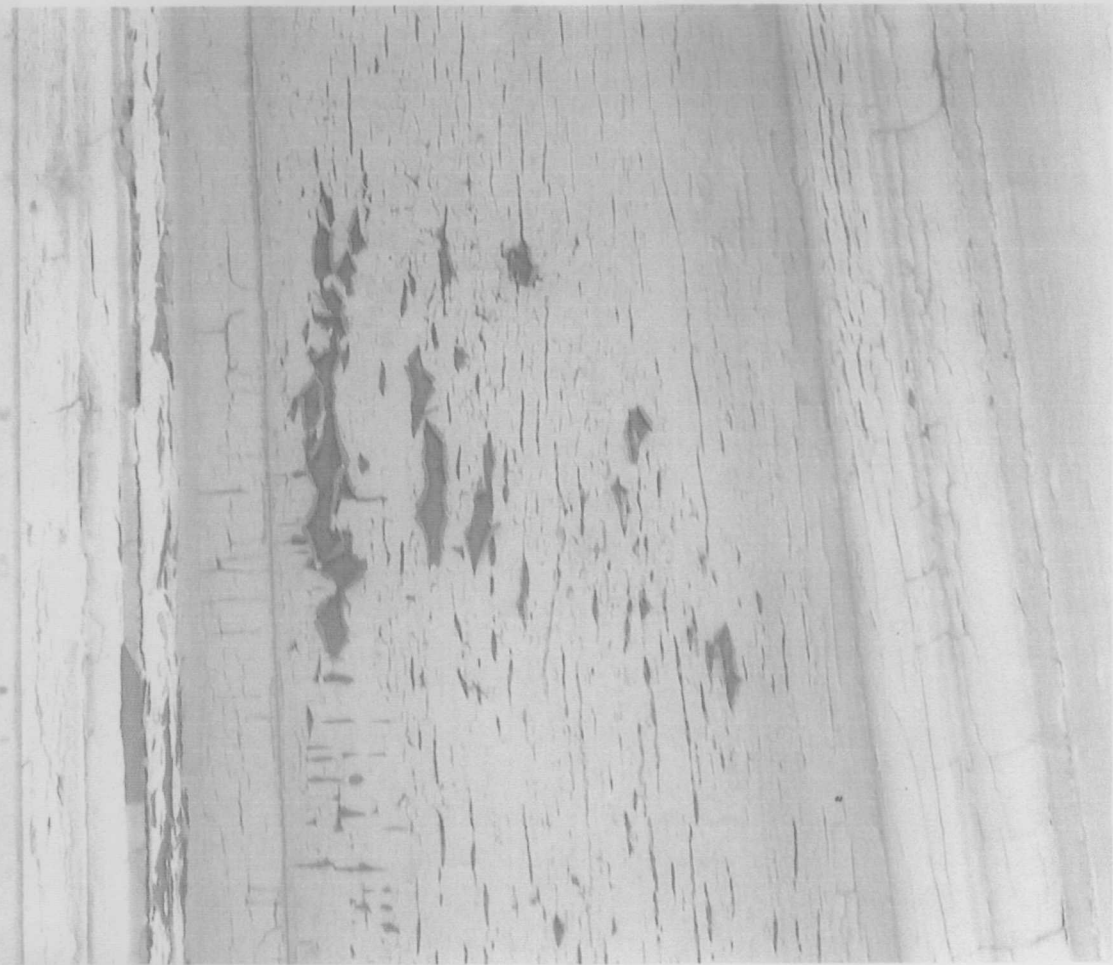
I.D. 2379  
Address: 4781 Race St.  
View: North Soffit

Window Trim/Fascia/Soffit				Patios/Decks/Porches			
	Material	Area	Peel/Chip	XRF (Lead)	Material	Area	Peel/Chip	XRF (Lead)
North	Wood Soffit	92 □	Peeling	23.4	Soffit	42 □	Peel/trim	15.2
South	Wood Soffit	92 □	Peeling	23.4				
East	Wood	18 □	Peeling	23.4	porch wood	48 □	Cracked/gray	23.3
West	Wood	18 □	Peeling	23.4				
	Total				Total

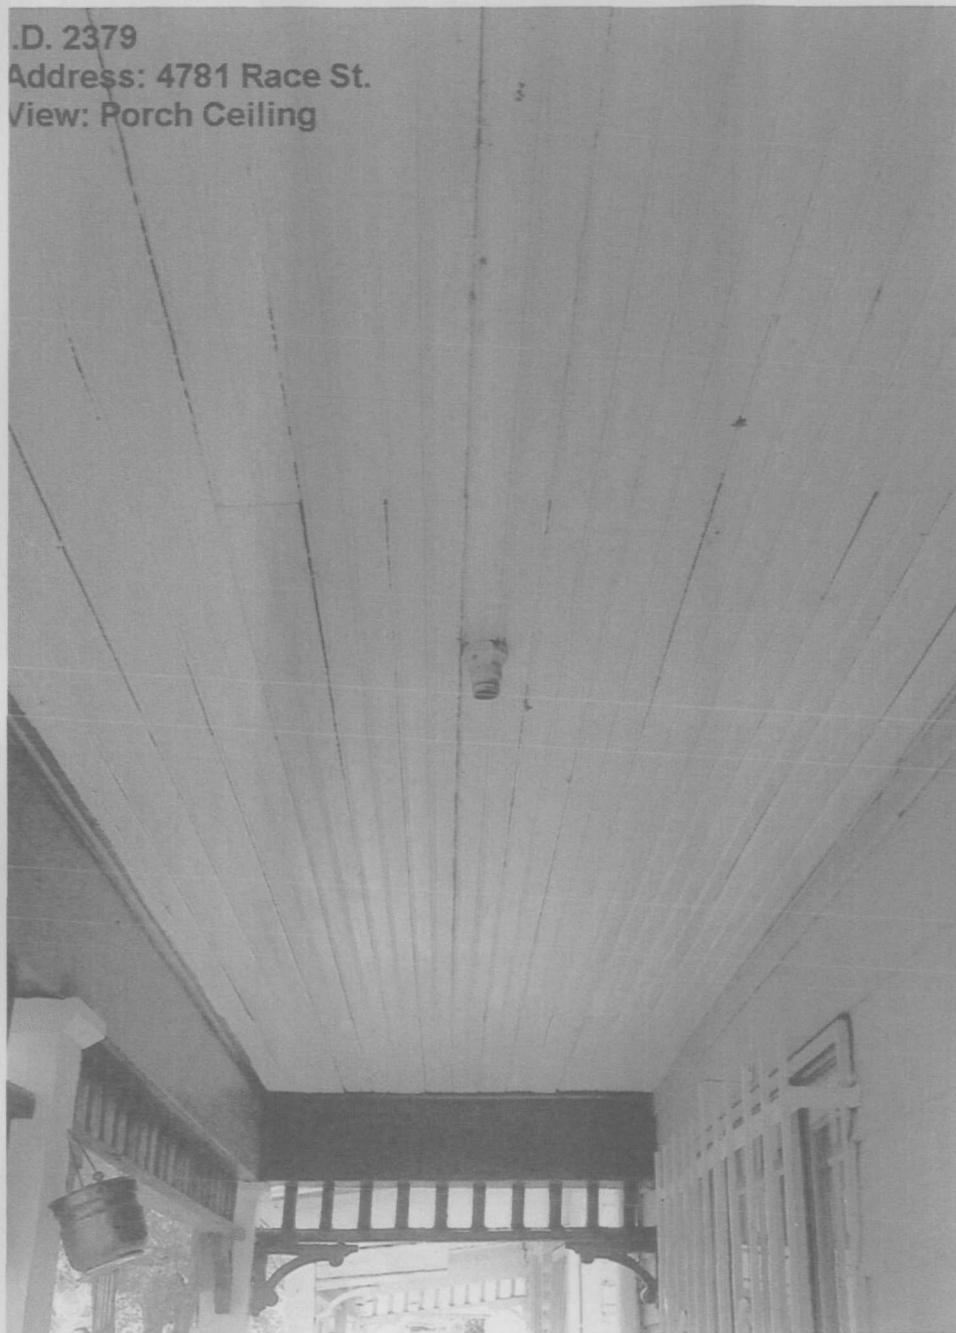
View: Porch Ceiling

Metal Trim/Gutters/Downspouts				<u>Porches</u> <u>Misc Structures/Garage/Fences</u>			
	Material	Area	Peel/Chip	XRF (Lead)	Material	Area	Peel/Chip	XRF (Lead)
North								
South					East Ceiling	42 □	Cracked	12.7
East					Wood Header	72 □	Cracked/gray	13.8
West								
	Total				Total

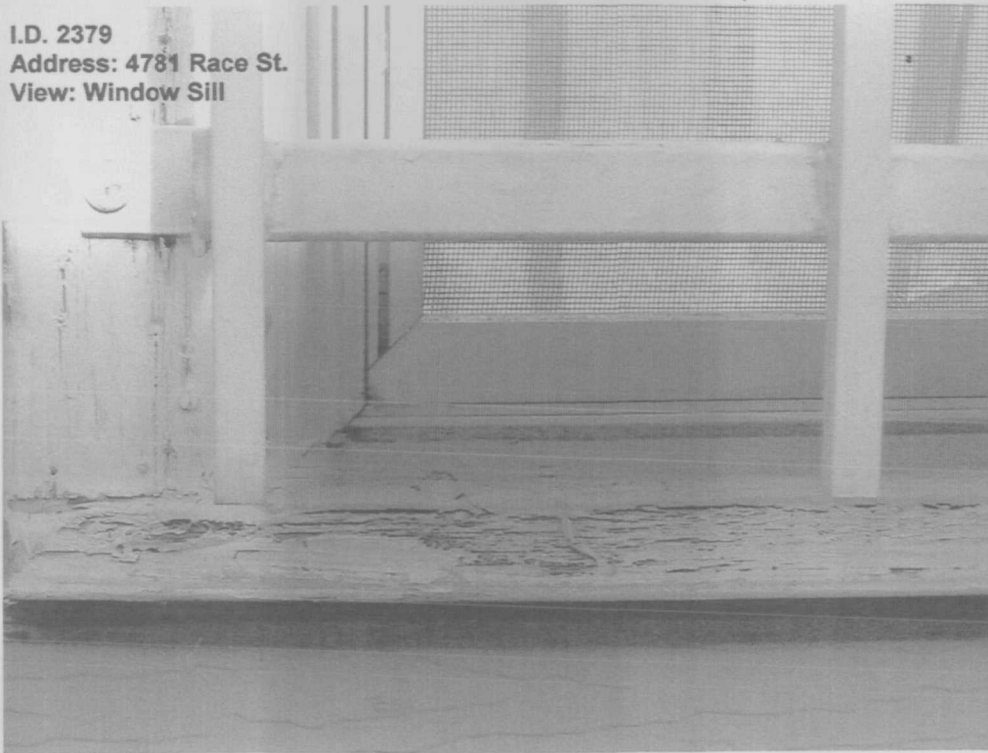
I.D. 2379  
Address: 4781 Race St.  
View: Window Sill

Exterior Walls				Doors/Trim <u>Window trim</u>			
	Material	Area	Peel/Chip	XRF (Lead)	Material	Area	Peel/Chip	XRF (Lead)
North	Alum/siding				Door trim	8 □	Peel	21.9
South	Alum/siding				Wood	6 □	Peel	—
East	Alum/siding							
West	Alum/siding				Wood	6 □	Peel	16.7
	Total				Total

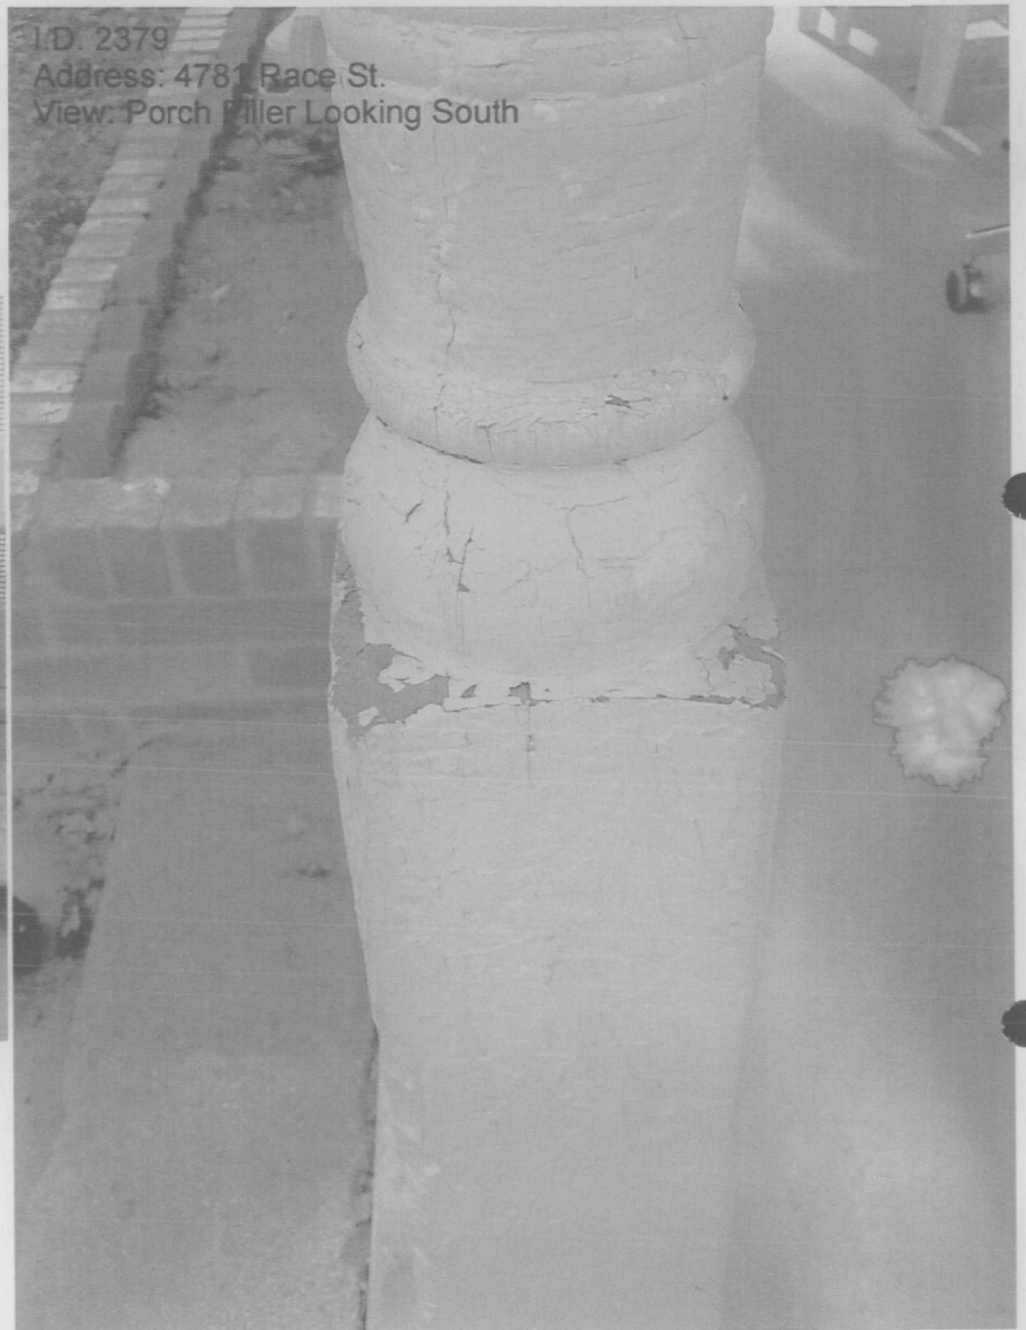
I.D. 2379  
Address: 4781 Race St.  
View: Porch Pillar Looking South

Time	Site	Component	Substrate	Side	Condition	Color	Floor	Room	Results	Depth Ind.	PbC	PbC Error
11/10/2005 10:25	2379	COLUMN	WOOD	EAST	CRACKED	GREEN	FIRST	PORCH	Positive	4.62	23.3	1.5
11/10/2005 10:28	2379	HEADER	WOOD	EAST	CRACKED	BLACK	FIRST	PORCH	Positive	3.17	13.8	0.9
11/10/2005 10:38	2379	SOFFIT	WOOD	NORTH	PEELING	TAN	FIRST	PORCH	Positive	4.27	15.2	1.8
11/10/2005 10:40	2379	CEILING	WOOD	EAST	CRACKED	WHITE	FIRST	PORCH	Positive	4.58	12.7	5.1
11/10/2005 10:42	2379	SOFFIT	WOOD	SOUTH	PEELING	TAN	SECOND	OUTSIDE	Positive	6.1	23.4	2.3
11/10/2005 10:46	2379	WINDOW FRAME	WOOD	WEST	PEELING	WHITE	FIRST	OUTSIDE	Positive	4.68	16.7	1.9
11/10/2005 10:48	2379	WINDOW FRAME	WOOD	SOUTH	PEELING	WHITE	FIRST	OUTSIDE	Negative	1	0	0.02
11/10/2005 10:51	2379	EXT.WALL	WOOD	NORTH	PEELING	WHITE	FIRST	NEIGHBOR	Positive	10	22.2	2.2
11/10/2005 10:52	2379	DOORFRAME	WOOD	NORTH	PEELING	WHITE	FIRST	OUTSIDE	Positive	4.02	21.9	2.2
<b>Note: Readings are in mg/cm²</b>
